# Chapter 2 PROGRESS ON THE WORLD TRADE CENTER INVESTIGATION

#### 2.1 STATUS OF DATA COLLECTION EFFORTS

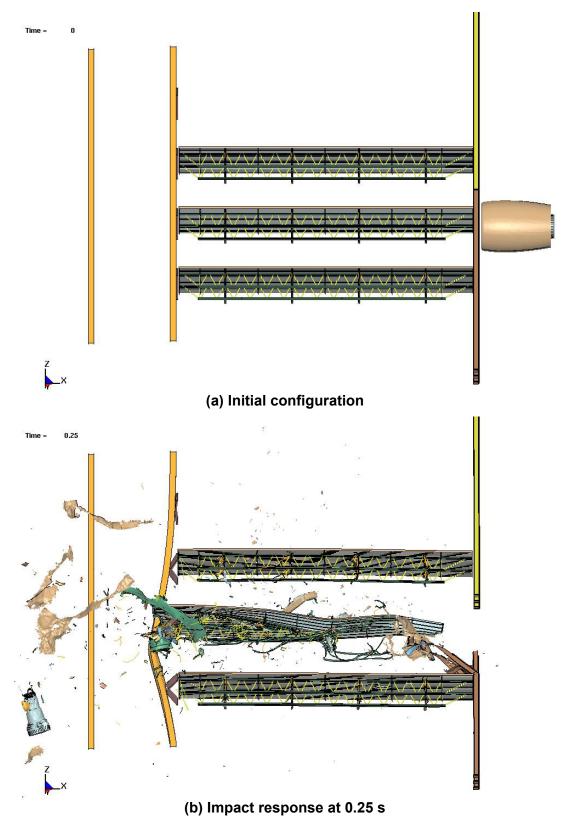
Figure 2–2. Example engine impact subassembly analysis.

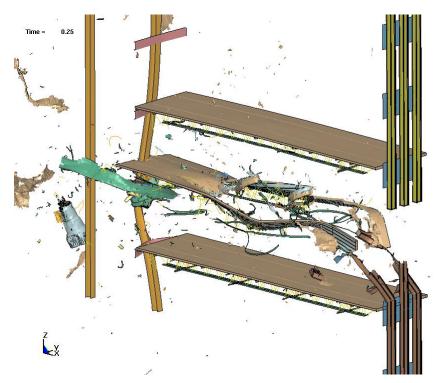
Figure 2–3. Oblique view of the subassembly engine impact damage.

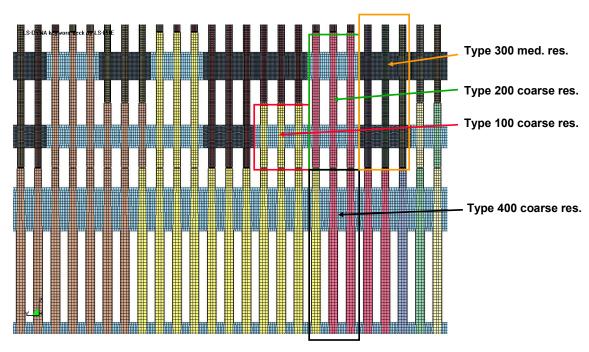
Figure 2–6. Detail of the WTC 2 impact zone exterior column panels.

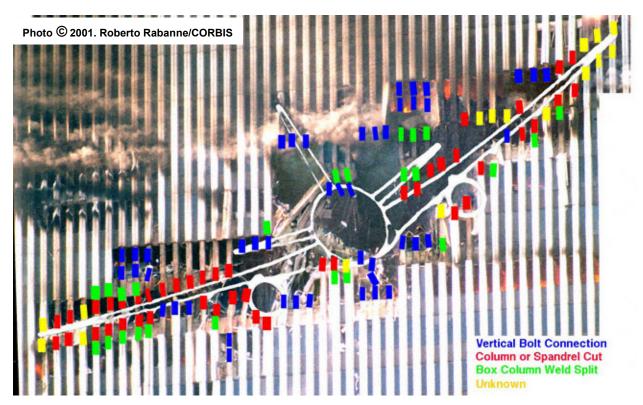
Figure 2–7. Enhanced precollapse image of the north face of WTC 1 with superimposed outline of the Boeing 767. Likely failure modes of damaged columns are indicated.

The recovered steel has been studied to determine failure modes of the various components and connections. In addition, a NIST contractor, Wiss, Janney, Elstner, has surveyed the recovered steel to characterize failure behavior.

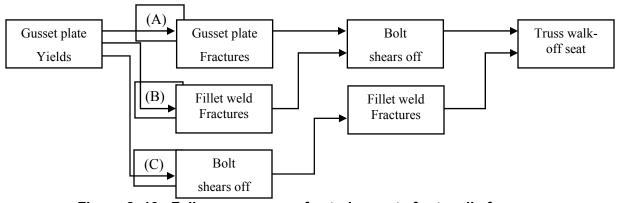
The failure modes considered for the truss-to-column connections are: (1) failure of the groove weld between gusset plate and spandrel, (2) failure of the fillet weld between the gusset plate and the truss top chord, (3) tensile failure of the gusset plate, (4) bolt shearing off, (5) bolt bearing, (6) bolt tear-out, and (7) block shear failure. Possible failure sequences are illustrated in Fig. 2–13. Of the seven exterior connections types that were analyzed, path A is the failure sequence most frequently followed, which is described as follows: first the gusset plate yields across its section and then fractures, followed by truss sagging and deformation and the bolts slipping until they bear against the edge of the slotted hole, then the bolt shears off, and finally the truss walks off the seat. The travel distance for the truss to walk-off of the seat is 4 5/8 in. Sequence (A) and typical tensile force resistance for an exterior seat is shown in Fig. 2–14.

Figure 2–13. Failure sequence of exterior seats for tensile forces.

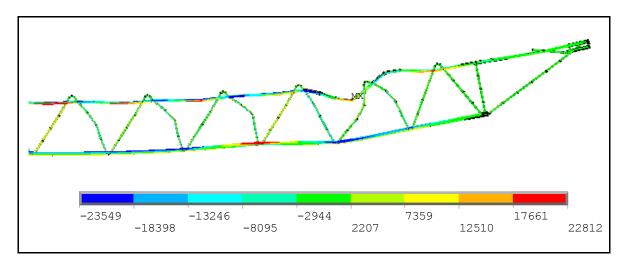
Figure 2–16 shows that the top chords of the truss yield in compression beyond 300 °C (for clarity, the concrete floor slab is not shown). This is due to a significant difference of coefficients of thermal expansion (CTE) between concrete and steel. At 500 °C, the CTE of steel is twice that of light-weight concrete. Bottom chords remain in the elastic range throughout the thermal loading. Web diagonal buckling starts around 350 °C and, as seen in the figure, some diagonals are bent significantly in the plane of the truss by high axial force and end moments.

Figure 2–16. Finite element solution for floor truss under gravity and temperature loads.

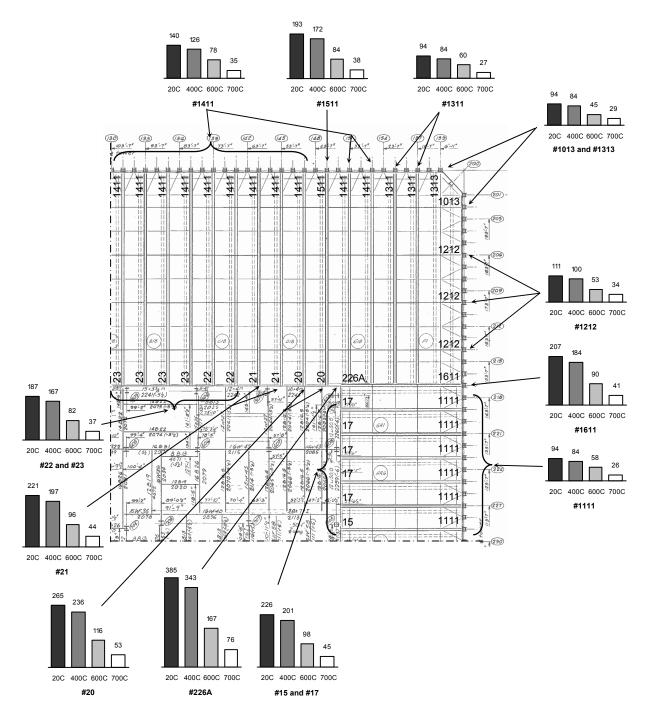
Failure mode of the interior truss seat for vertical force is the fracture of the fillet welds at the seat-to-channel beam connection. Failure mode of the exterior truss seat for vertical force is fracture of the fillet welds at the stand-off-to-spandrel connection. Preliminary findings of connection capacities for vertical bearing forces at room temperature (20 °C), 400 °C, 600 °C, and 700 °C are summarized in Fig. 2–17.

Figure 2–17. Truss seat capacity for vertical forces.

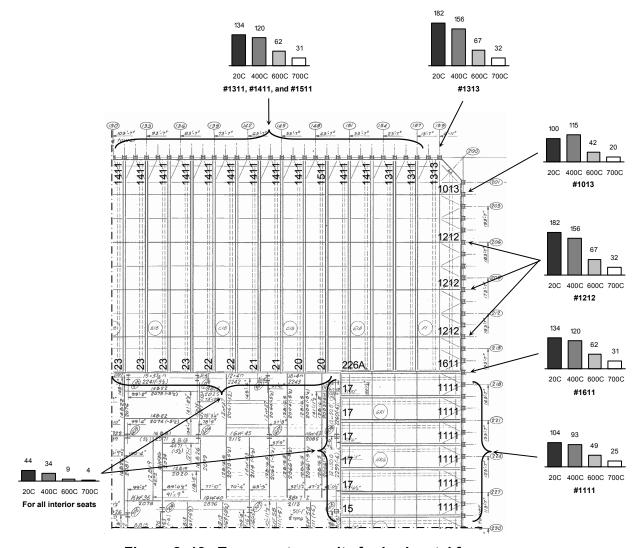
Similarly, connection capacities for horizontal tensile forces at the same temperatures are shown in Fig. 2–18. For interior truss seat connections, the shear strength of the two bolts controls the horizontal tensile capacity. The connection capacity of exterior truss seats that follow failure sequence (A), as shown in Fig. 2–13, equals the failure load for the tensile capacity of the gusset plate. Note that the strength of the truss seat #1013 increases by approximately 38 percent at a temperature of 100 °C. For temperatures less than 100 °C, the horizontal capacity is controlled by the gusset fillet weld strength, and for temperatures above 100 °C, the bolt bears against the edge of the slotted hole and increases the capacity of the connection.

Figure 2–18. Truss seat capacity for horizontal forces.

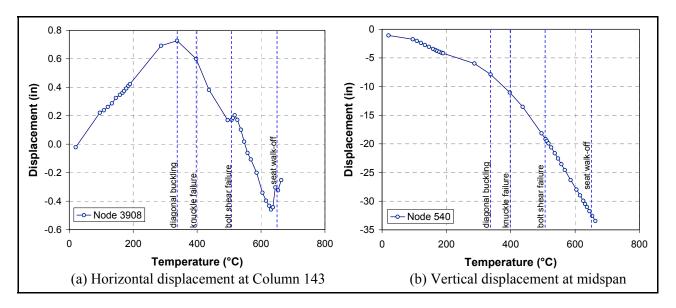
The floor truss analysis was carried out dynamically with 5 percent Rayleigh damping and a temperature ramp set to 1.0 s. The floor slab had only gravity loads applied; no other loads related to floor diaphragm action were included. The analysis of truss behavior under the gravity plus thermal loading proceeded to a temperature of T=663 °C. Figure 2–20 shows the horizontal displacement of the column and the vertical midspan displacement of the truss. A positive horizontal displacement indicates that the exterior columns are pushed out, and a negative vertical displacement indicates that the truss is deflected downward.

Figure 2–21. Floor truss response due to gravity load and uniform heating.

As the truss and floor slab heat up, the column is pushed outward by thermal expansion. The trust top chord begins to yield in compression around 300 °C due to the difference in coefficient of thermal expansion between steel and lightweight concrete. At approximately 340 °C, web diagonals begin to buckle and the horizontal displacement at the exterior column reverses and begins to decrease. At 400 °C, knuckles start to fail sequentially from both interior and exterior supports toward the center. With the loss of composite action, the floor begins to sag at an increasing rate. Eventually, at about 500 °C, with the truss sagging almost 20 in., the bolts at the interior connection are found to shear. At 560 °C, the exterior columns begin to displace inward, and the truss begins to act as a catenary. At 650 °C, the truss walks off the interior seat while the interior end of slab remains intact and continues to carry vertical load. For the truss to walk off the interior seat, the truss must shorten by 4 in. This shortening is caused mainly by the significant plastic deformation of the top chord of the truss (Fig. 2–14), resulting from differences in the thermal expansion of the top chord relative to the slab and the failure of the first two knuckles near the interior seat. At roughly 660 °C, the gusset plate fracture at the exterior end which precipitates vertical failure of the exterior seated connection.

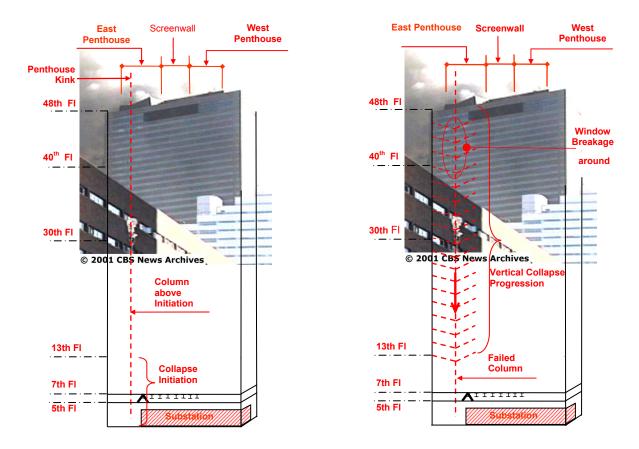
- Interior columns 79, 80, and 81, were located directly below the east penthouse on the roof and supported large tributary areas. The tenant floor areas on the east side of the building had spans of approximately 50 ft between columns. Their failure would likely result in failure of the tributary floor system, as analysis indicates that the floors would not be able to redistribute their loads. This failure mechanism would progress vertically upward within the failed bay to the roof level, and would not be visible from the exterior until the east penthouse lost support, as shown in Fig. 2–23. Available information on the floor-to-column connections indicate that the connections would fail under this scenario without significantly damaging the perimeter or interior columns.

Figure 2–23. Collapse initiation and vertical progression on the east side of WTC 7.

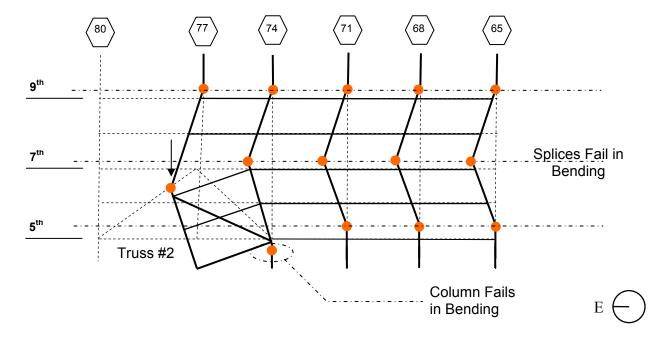
- The debris pile from a vertical failure progression on the east side of the building would damage or sever transfer girders and trusses between the fifth and seventh floors, shown in Fig. 2–24. Two system responses to this secondary damage have been postulated and are being further investigated. (1) The columns supported by these transfer components would become unstable, and their loads would transfer to adjacent core columns. If the columns could not support the transferred loads, the column instability would progress sequentially to adjacent core columns. (2) The floor-to-column connections in the fifth and seventh floors are strong enough to impose lateral displacements upon the other core columns, particularly in the center of core where there were elevator areas without reinforced concrete slab. Such a horizontal pull would fail the columns at their connection near the seventh floor, as shown in Figs. 2–25 and 2–26.

Figure 2–25. Example of horizontal progression of failure in core columns following damage to transfer components on the east side of the building.

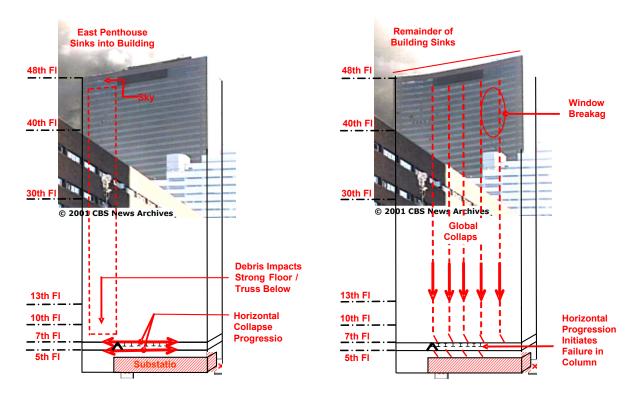
- The core columns failed sequentially and redistributed loads until the building loads could no longer be supported, and the global collapse occurred with few external signs prior to the system failure, as illustrated in Fig. 2–26.

Figure 2–26. Horizontal progression to the west side of WTC 7.
